INSPECTION REPORT

Inspection Report # 041115 - TURNER

Subject Property Address: 305 N. Second Ave. ~ Upland, CA. 91786

Inspection Day: Friday ~ Date: 4 / 15 / 2011 ~ Time: 9:00 am

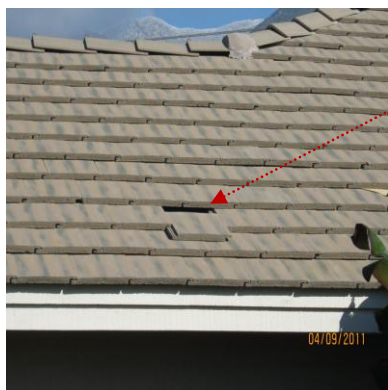
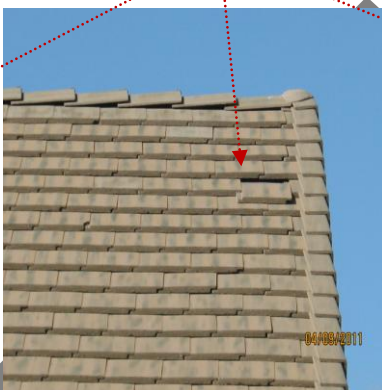
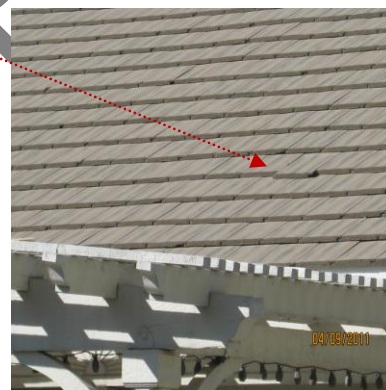
1. Evidence of damaged / inadequately secured roof tiles was observed at the roof deck(s). Recommendation: Obtain a detailed and comprehensive evaluation of the entire roof surface, including any remedial recommendations, by a qualified and state licensed Roofing Contractor (C39).

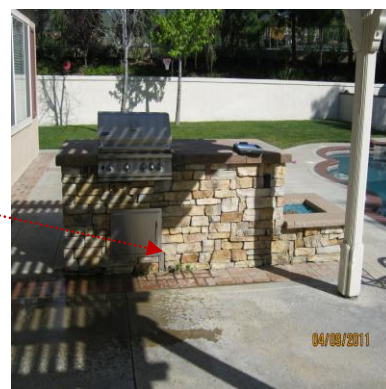
2. The gas supply shut-off valve for the gas fire pit was not installed close enough to the flame source. Recommendation: Obtain a detailed and comprehensive evaluation, including any remedial recommendations, by a qualified and state licensed Plumbing Contractor (C36).

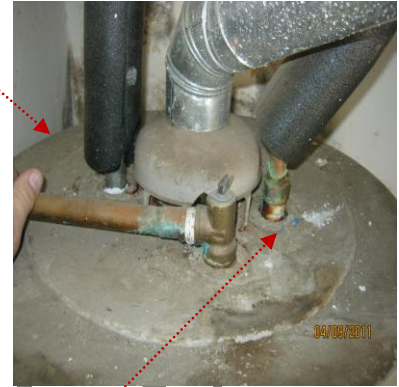
3. Evidence of excessive rust and/or corrosion was observed at the water heater tank. This may be an indication of an active leak and limited remaining life of the water heater. Recommendation: Obtain a detailed and comprehensive evaluation, including any remedial recommendations, by a qualified and state licensed Plumbing Contractor (C36).

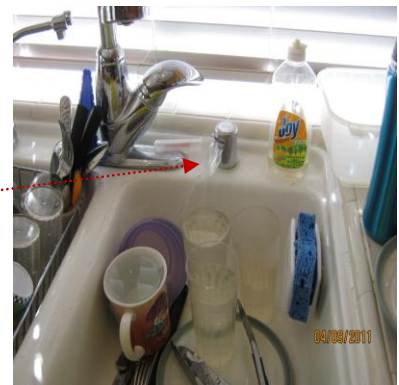
8. Evidence of active water leakage at dishwasher air gap device was observed during the drain cycle. This is an indication of a restricted or defective air gap device and may allow water to leak into the cabinet below the sink. Recommendation: Obtain a detailed and comprehensive evaluation, including any remedial recommendations, by a qualified and state licensed Plumbing Contractor (C36) and correct as needed.

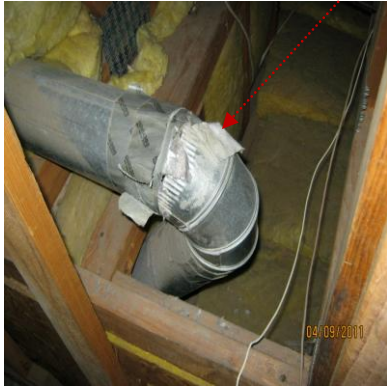
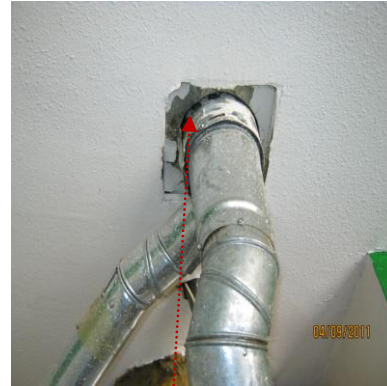
10. Evidence of disconnected dryer vent ducting at the Attic was observed. The ducting bends 90 degrees. This will limit the ability of the dryer to vent properly. Recommendation: Obtain a detailed and comprehensive evaluation, including any remedial recommendations, by a qualified and state licensed Plumbing Contractor (C36).

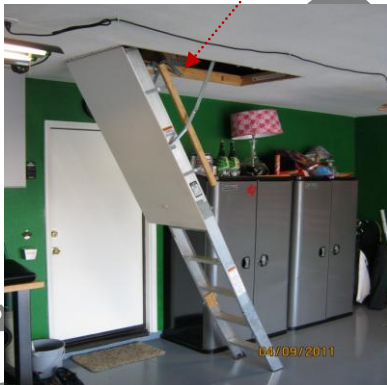
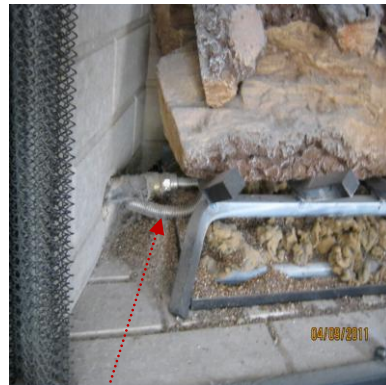
11. Evidence of gaps around the furnace exhaust piping penetration was observed. This is considered a breach of the firewall's integrity and a possible fire safety concern. Recommendation: Obtain a detailed and comprehensive evaluation, including any remedial recommendations, by a qualified and state licensed General Building Contractor (B-1).

12. The installation of an access door / pull down ladder was observed in the garage ceiling. The Garage ceiling in this structure may serve as part of the firewall system. This may be considered a breach of the firewall's integrity and a fire safety concern. Recommendation: Contact the local Building Department prior to closing for the requirements/limitations of this condition and correct as needed by finishing the firewall in the Garage Attic or removing the ladder and sealing the Garage ceiling.

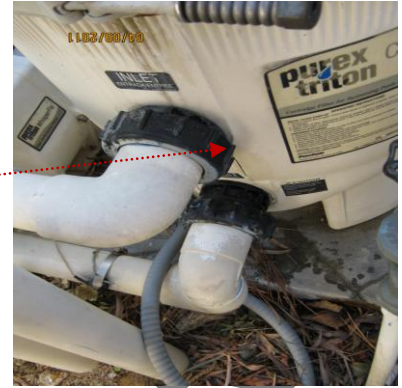
14. Evidence of active water leaks at the plumbing connections at the filter were observed. Recommendation: Obtain a detailed and comprehensive evaluation, including any remedial recommendations, by a qualified and state licensed Pool/Spa contractor (C53).

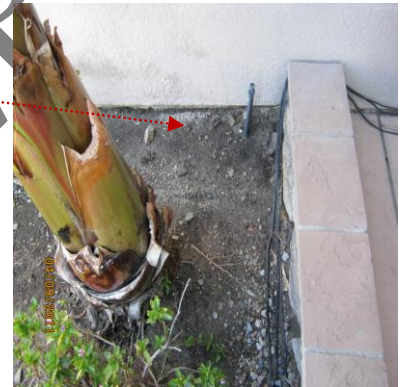
Evidence of soil levels higher than what is recommended at one or more locations around the structure was observed Recommendation: Re-grade these areas so that the soil is at a proper level away from the foundation to allow for proper drainage and/or improve drainage provisions. Also, refer to any current Termite report for further information regarding this condition.

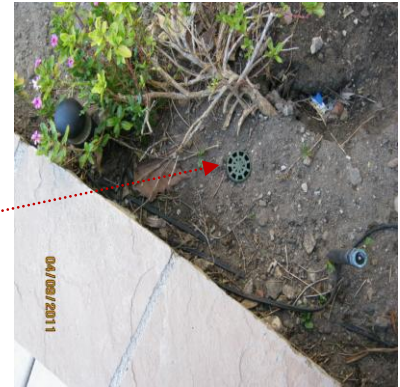
The underground drainage system appears to have been installed after original construction of the subject dwelling. Recommendation: Consult with the current **Owner** or **Agent of Record** to obtain any documentation regarding this installation and also consult with the local Building department to verify that a permit was issued for this installation and that final approval obtained.

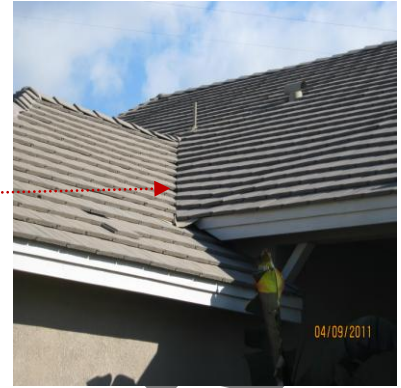
The roof tiles were not adequately cut-back at the valleys to allow adequate water flow off the roof deck. This condition will also allow debris accumulation in the valleys. Recommendation: Obtain a detailed and comprehensive evaluation of the entire roof surface, including any remedial recommendations, by a qualified and state licensed Roofing Contractor (C39).

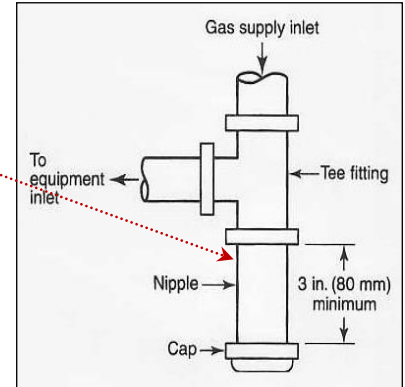
A gas piping sediment drip leg was not installed at the water heater and furnace gas supply lines as required by the manufacturer's installation instructions and/or recognized building standards. Recommendation: Consult with a representative from the local Building department and/or the local gas utility regarding the requirement for this component and obtain a detailed and comprehensive evaluation, including any remedial recommendations, by a qualified and state licensed Plumbing Contractor (C36).

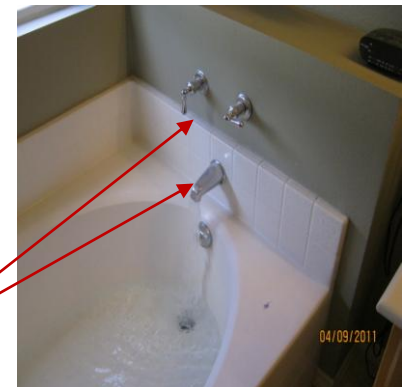
Evidence of inadequately secured faucet was observed at the Master Bedroom Bathroom bathtub. Recommendation: Correct as needed.

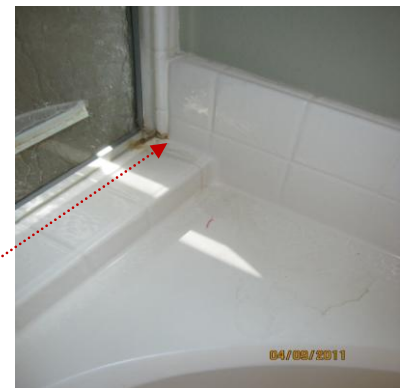
Evidence of water leakage at the bottom edge or door of the Master Bedroom Bathroom(s) shower enclosure was observed. Recommendation: Repair or replace as needed.

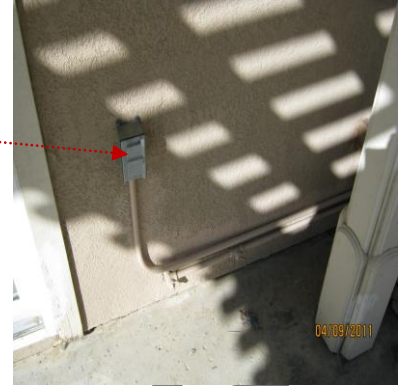
The Exterior (Rear of the structure) GFCI circuit was tested, responded by tripping at a primary location (Garage), but could not be reset at the origin. This is an indication that the GFCI receptacles that were added were not needed since these circuits are protected by the primary GFCI. This redundancy is an inconvenience but may affect the circuit. Recommendation: Obtain a detailed and comprehensive evaluation, including any remedial recommendations, by a qualified and state licensed Electrical Contractor (C10).

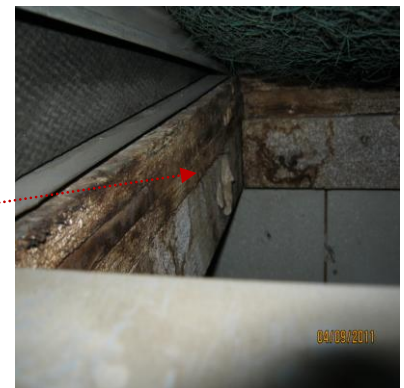
Evidence of water staining on the interior surfaces inside the return-air compartment was observed. The **Inspector** was unable to determine the exact origin or current status of these stains. Recommendation: Consult with the current **Owner** or **Agent of Record** for any historical disclosure regarding this condition and correct as needed.

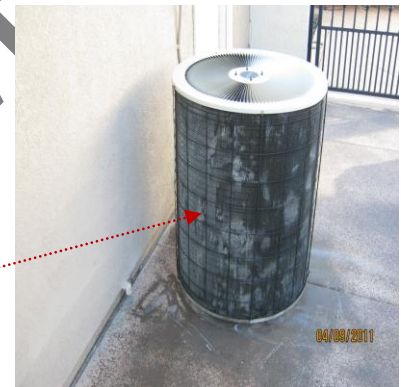
The air conditioning system compressor / condenser was not elevated at least 3" above surrounding grade or flatwork to prevent damage / deterioration and was not adequately secured at the base. Recommendation: Correct as needed.

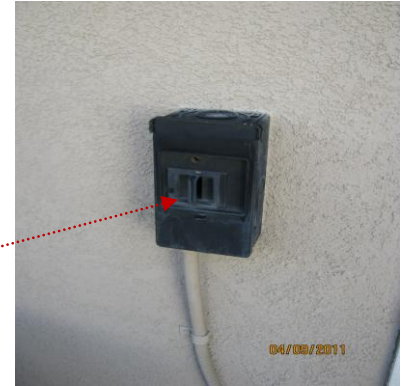
The air conditioning system compressor / condenser electrical disconnect box was missing the exterior weather cover. Recommendation: Correct as needed.

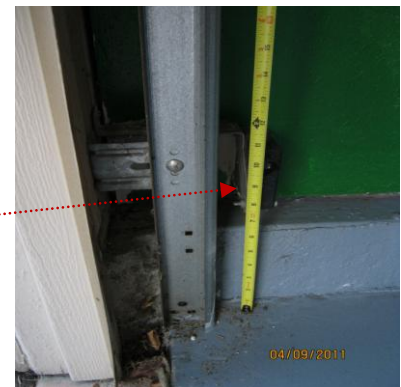
The light beam motion sensors for the 1-car garage door opener were measured to be 10 inches above the bottom of the Garage door frame. The maximum allowable height as mandated by UL 325 standard, the manufacturer's installation requirements and the Consumer Products Safety Commission is 6". Recommendation: Correct as needed if an opener is installed.
